TECHNICAL REPORT

Oil seal with cover assembly 71012300 / 71006300

The reason for this report is to provide a detailed guide for the correct assembly of the seal with cover 71012300 / 71006300. This seal is for different models of the following brands: Fiat, Mercedes - Benz, Nissan, Opel, Renault and Vauxhall.

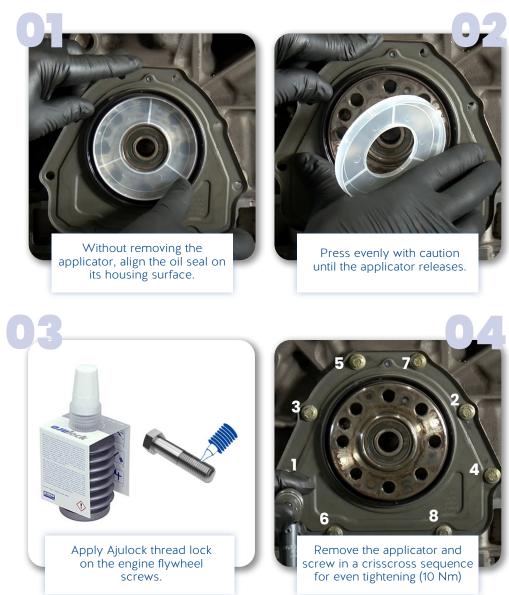
LET'S ASSEMBLE!
