# TECHNICAL REPORT

Assembly of the cylinder head  
cover with reference Ajusa  
11117200

## 01 introduction

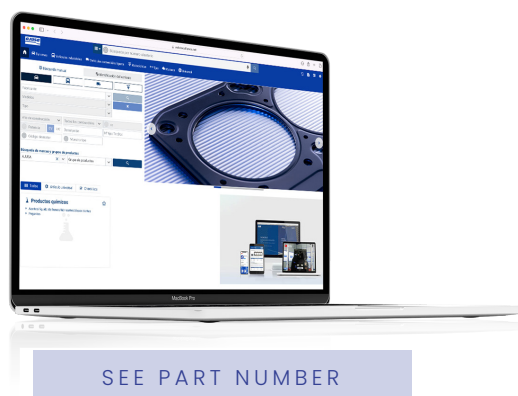
### OEM part number

0249.C6

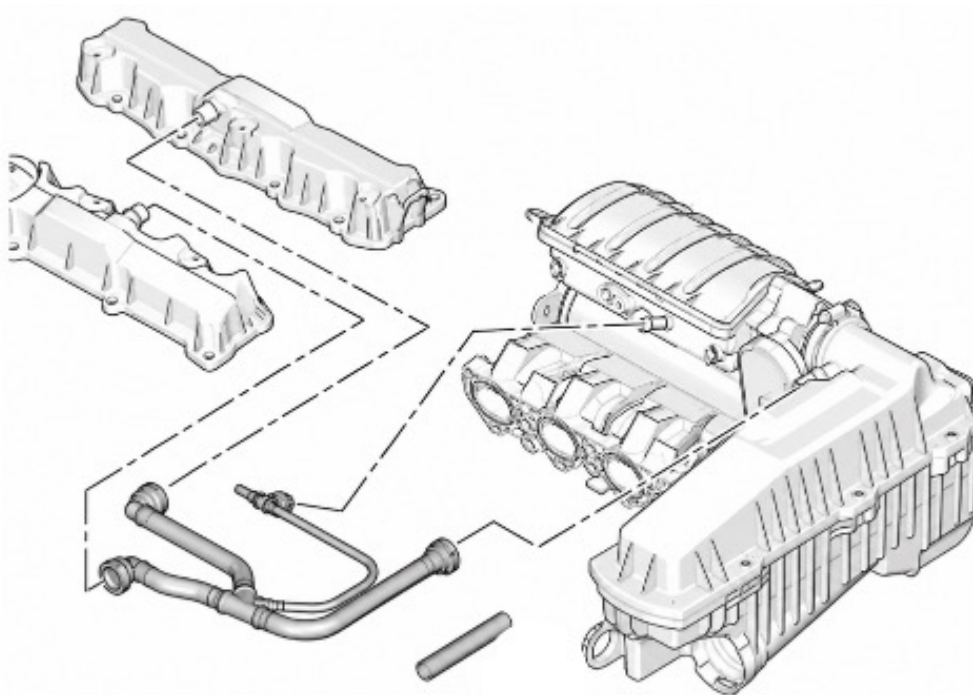
If the PCV valve is stuck or not working properly (especially if it is locked closed), internal overpressure is generated in the engine.

This overpressure seeks to “exit” through the weakest points: cylinder head cover gaskets, intake manifold gaskets and eventually other gaskets (crankshaft seal, etc.) causing possible oil leaks and deterioration of the gasket.

If the PCV valve is constantly left open, it can allow too many oil-laden gases to enter the intake. This can foul the intake, intake valves, and form deposits in the combustion chamber.
