# BMW N47 Timing Chain Issues

*Understand the cause. Diagnose the symptoms.  
Fix it right.*

## TECHNICAL BULLETIN: TB0092

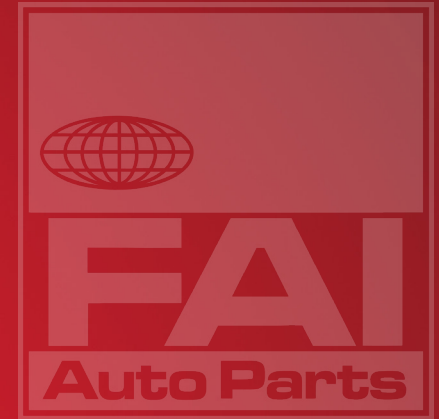
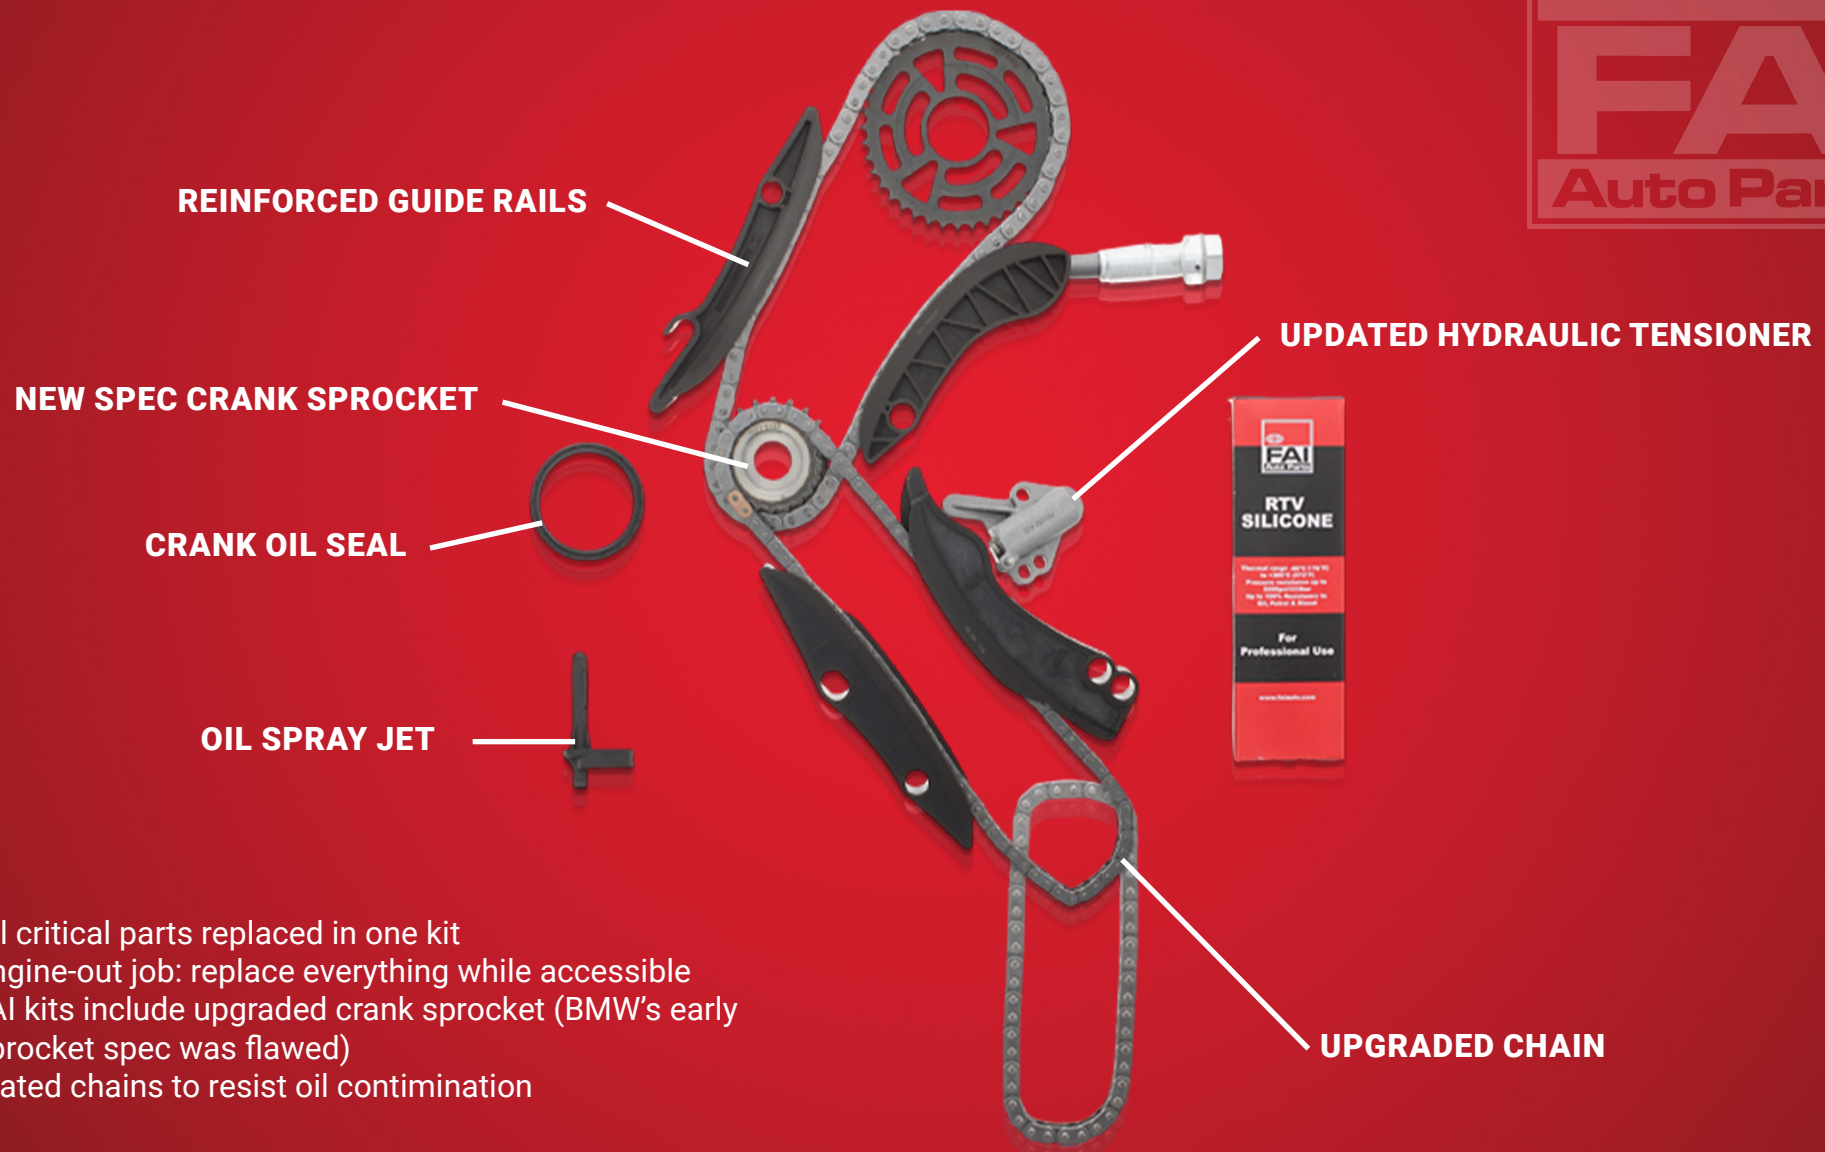
# FAI TIMING CHAIN KIT

- All critical parts replaced in one kit
- Engine-out job: replace everything while accessible
- FAI kits include upgraded crank sprocket (BMW's early sprocket spec was flawed)
- Plated chains to resist oil contamination

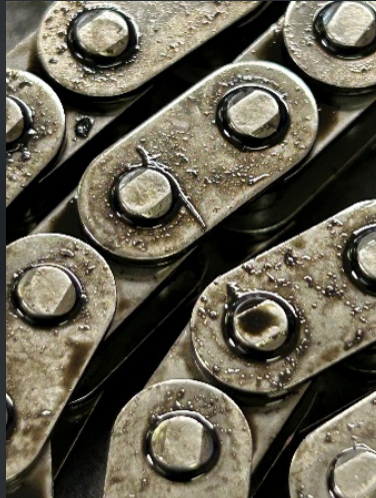
Heavy carbon build up and debris on returned parts. This is caused by many factors from age to malfunctioning breather systems and EGR. Long service intervals allows carbon to build up within the engine which can be accelerated by many other factors. Carbon build up is the number 1 cause of replacement chain failure

FAI highly recommend thoroughly cleaning the oil system of the vehicle before chain replacement. Carbon particles dislodged by removal of the parts will be forced into the new tensioners as oil pressure rises. The complete oil system needs to be as free from deposits as possible before the chain kit is replaced.

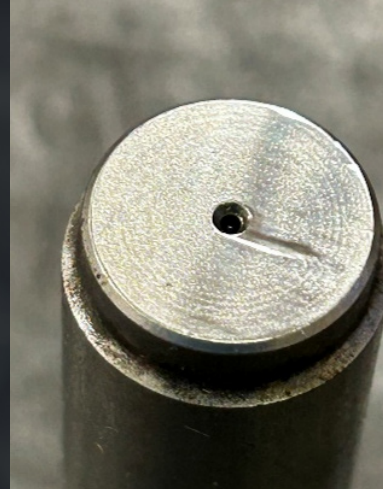
The Carbon blocks the oil pathways in the tensioners. This restricts the tensioners performing correctly which allows for inconsistent chain tension. The chain can then flail and forces the guides to hit against the tensioners and creates wear patterns on the tensioner crown and rear of the guides.
