PureTech 1.2l Engines  
EB2 Engine Stellantis Group

VKMA 03306 / VKMA 03307  
VKMA 03306-1 / VKMA 03306-2

### Case study PureTech 1.2l Engines

Problem: Extreme wear on the timing belt leads to clogged oil pump – Results in an engine damage

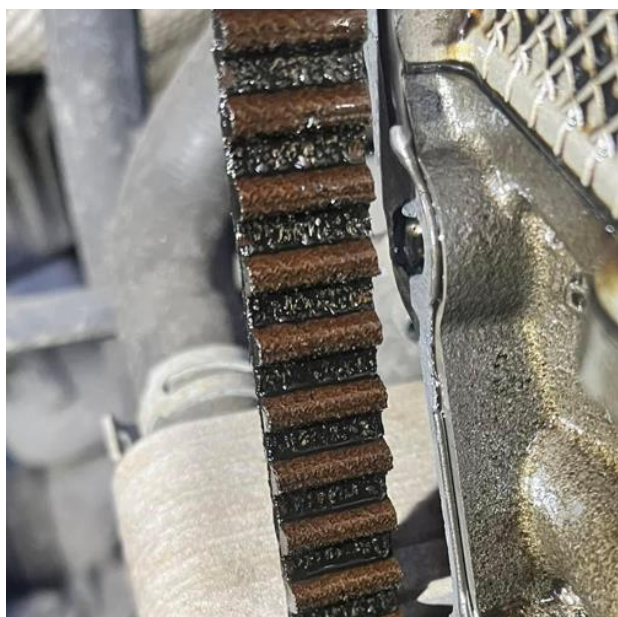
We have investigated several complaints in which the timing belt showed extremely high wear after a comparatively short period of time. This is due to abrasion of the belt material or even detached teeth.

Extremely worn-out timing belt.

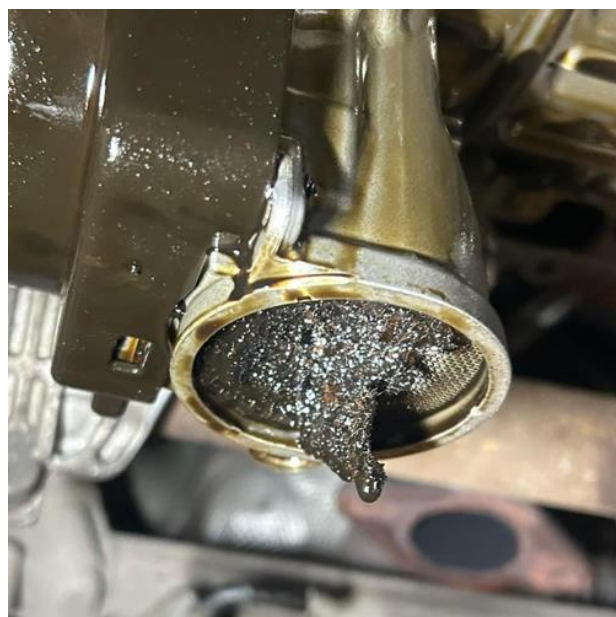
Oil pump clogged due to timing belt abrasion.

The main problem is the premature wear of the timing belt, which gradually decomposes. The resulting particles can clog the lubrication system and clog the solenoids of the variable valve control or the sieve of the oil pump (filter). This then leads to lubrication problems (loss of oil pressure) or to contamination on the camshaft and valves. The problem arises from the rapid breakdown of the engine oil, especially in vehicles that are driven relatively infrequently (less than 15,000 km per year) and mainly in city traffic. Under these conditions, the 1.2 PureTech is prone to oil dilution, with fine droplets of unburned fuel sliding down the cylinder walls and mixing with the oil in the sump below. The resulting mixture acts abrasively on the belt, explaining the wear.

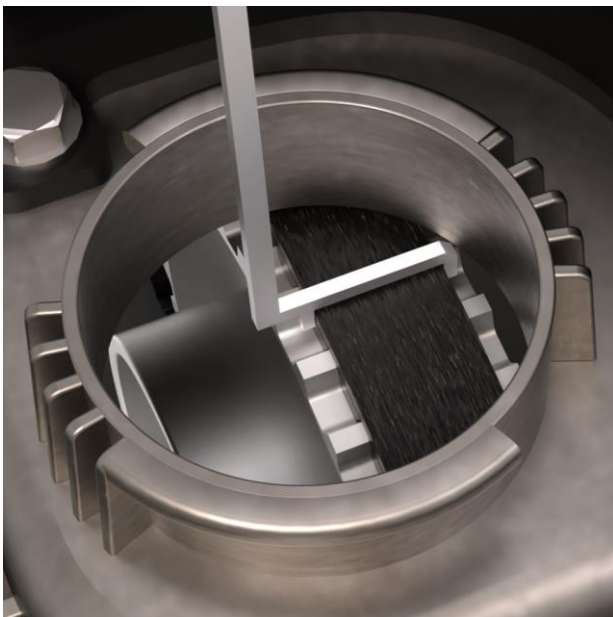
Access via the oil filler cap.

Since there is no technical solution to prevent this condition, the only way to protect the belt on these rarely used vehicles is to change the engine oil annually. This explains why the manufacturer recommends checking the belt condition through the oil fill hole at every routine service. When topping up, you are in fact pouring the oil into a hole located above the timing belt. You can see part of the belt through the same hole and thus determine its condition. In addition, it should be measured with a special gauge to evaluate the condition of the belt (Tool-OE: G-0109-6). Always measure the belt at three different positions.

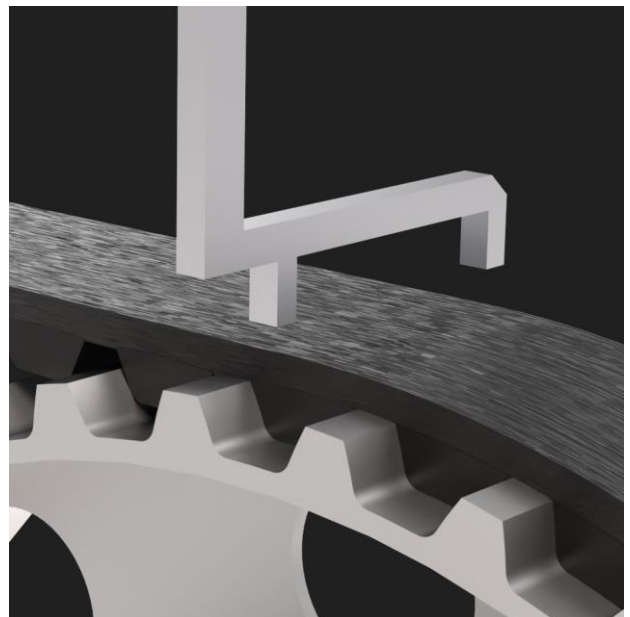
Always measure over a belt teeth.

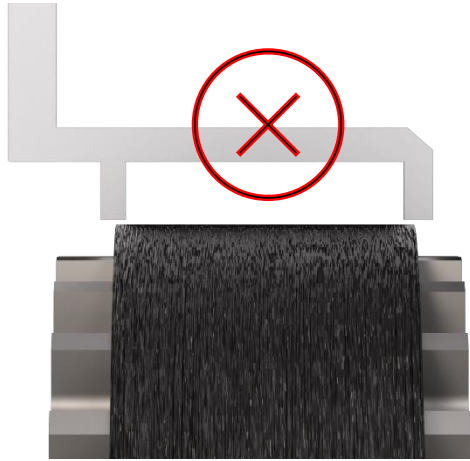
The belt has swelled up, the gauge no longer fits over the belt.

If the belt has swelled up it's mandatory to replace the timing belt and in addition check the condition of the oil pump:

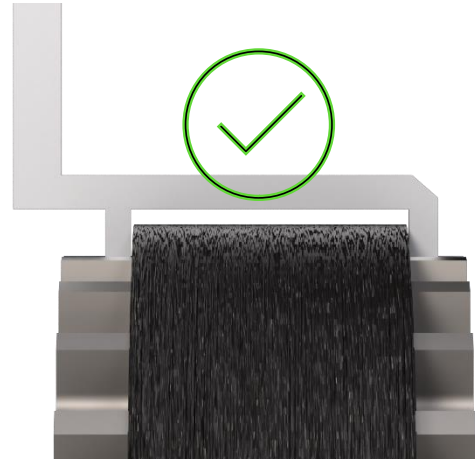
The gauge fits over the belt, the belt is ok.

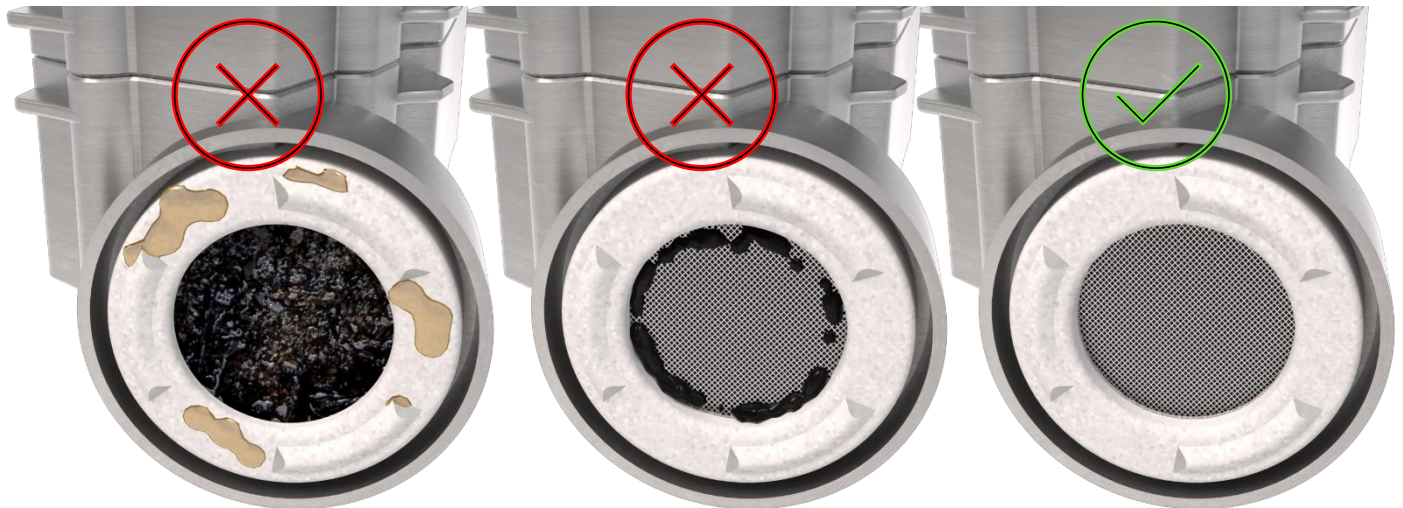
If contamination is visible in the oil strainer, the strainers of the two solenoid valves of the variable camshaft phasing unit and the oil strainer of the vacuum pump must also be checked for contamination and cleaned. These blockages are usually also associated with a fault in the oil pressure system, which leads to an active oil pressure warning light.

- Check and clean the two solenoid valves for the camshaft adjustment, replace if necessary
- Check and clean the oil strainer on the vacuum pump, replace if necessary
- Check and clean the oil pump strainer
- Replace the cap screw on the turbocharger oil connection
- Replace the oil and oil filter
- Check and clean the oil pressure control valve, replace if necessary
