Nissan Micra Clutch Replacement

The popular Nissan Micra has been in production since 1982. It has been sold worldwide in many numbers since its introduction and is now on its 5th generation – it is still a popular choice of car as ever. The model featured in this article is a 4th generation K13 model, fitted with the 1.2 three-cylinder petrol engine. The example shown in this article was reported to have a slipping clutch, which would require a clutch replacement.

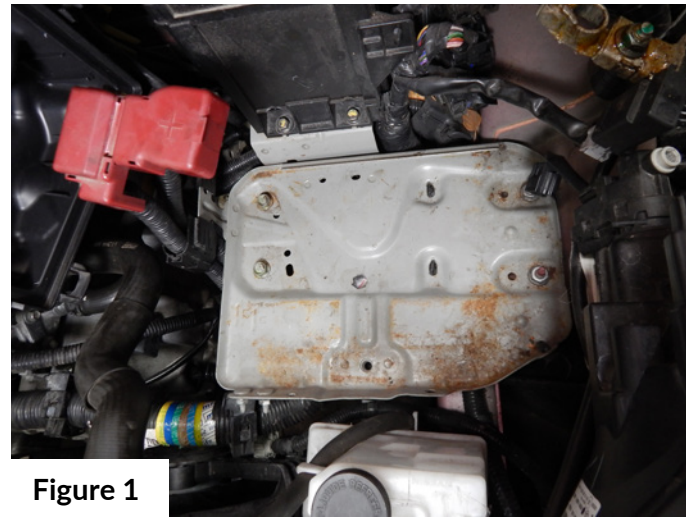
Figure 1

With the vehicle in the workshop, the bonnet was opened, and the battery and air cleaner assembly was removed. This was followed by the battery tray, which is held in place by four bolts, two nuts and has several retaining clips that hold different parts of the wiring harness in place. (Fig 1)

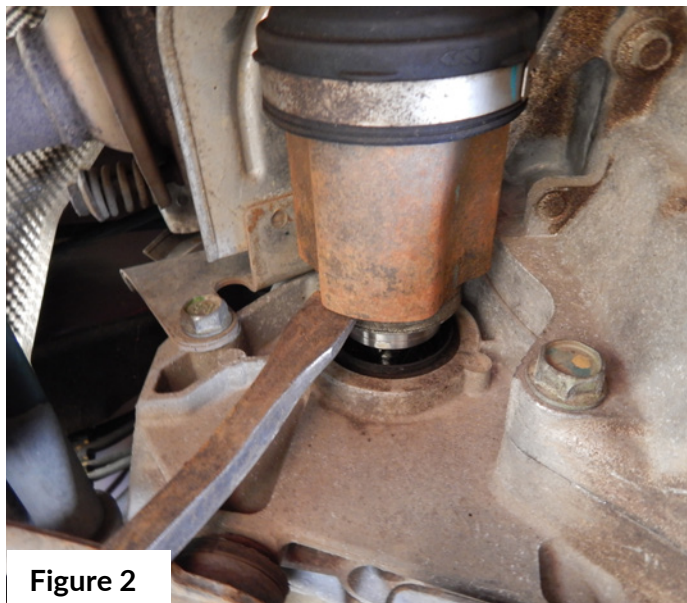
Figure 2

With a suitable pry bar, the driveshafts were levered out to release the retaining clips so that the driveshafts could be removed from the transmission, being careful not to damage the seals. (Fig 2)

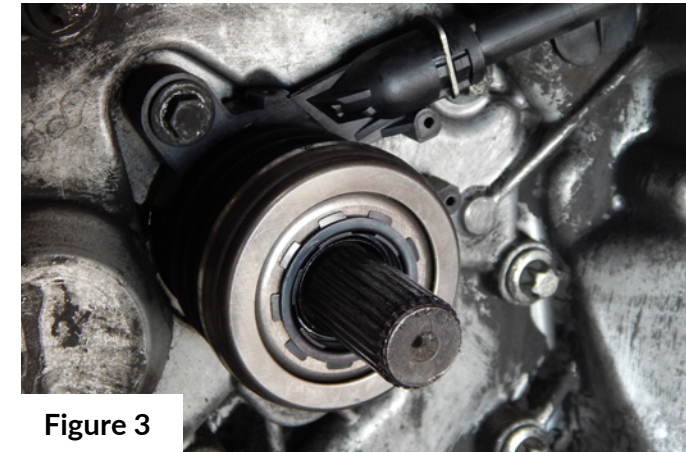
Figure 3

With the transmission removed, the clutch pressure plate and friction disc were removed and inspected. The friction plate material was worn down to its retaining rivets and needed immediate replacement. The flywheel was cleaned and inspected for defects before fitting the parts contained in clutch kit ADN130236. The attention then turned to the removal of the old CSC. Once removed, the transmission was cleaned of excess worn clutch material. Then, the input shaft seal was inspected for fluid leaks before fitted the new CSC. (Fig 3)

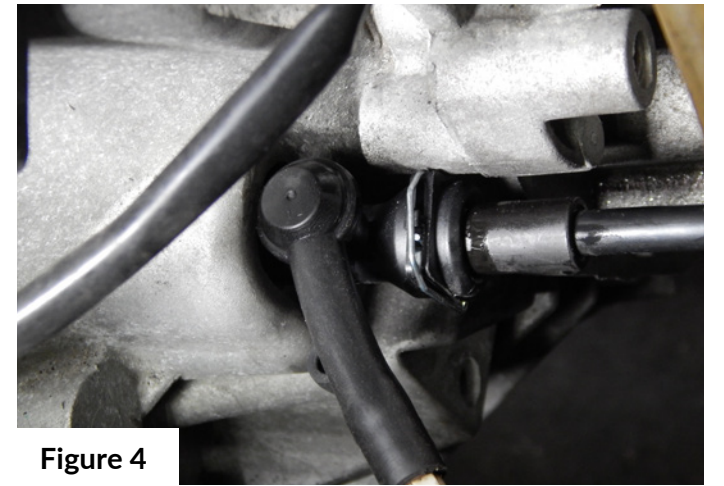
Figure 4

With all the new clutch parts fitted, the transmission was installed in reverse order and filled with the correct grade oil. The last thing to do was to bleed the air from the clutch hydraulic system. (Fig.4) The Blue Print clutch kit comes with a number of useful bulletins, one of which includes the clutch bleeding procedure.

1. First, top up the clutch fluid reservoir with new clutch fluid and then connect a transparent hose to the air bleeder of the bleeding connector which is part of the CSC. Do not use a vacuum or pressure bleeder on this system as this may cause damage to seals within the clutch hydraulic system.

2. Press the retaining clip down into the bleeding connector, and maintain the position – this is to release the clutch hydraulic tube.

3. Slide the tube back by approximately 5mm to release the retaining clip. This will allow clutch fluid to flow from the air bleeder. Hold the tube to prevent it from getting disconnected as the clutch fluid tube is under hydraulic pressure.

4. Get an assistant to depress the clutch pedal and hold it. Then, bleed the air from the CSC until no bubbles are observed in the clutch fluid.

5. Push the clutch tube back into its original position. Release the clutch pedal and wait 5 seconds. Make sure the retaining clip is complete and is in its correct position to retain the clutch tube.

6. Check that the fluid level in the reservoir is within the specified level during and after air bleeding. Check that the clutch pipe is correctly retained, and no chafing can occur.
