BMW Automatic Transmission

Oil leaks at the transmission also harm the vehicle and environment

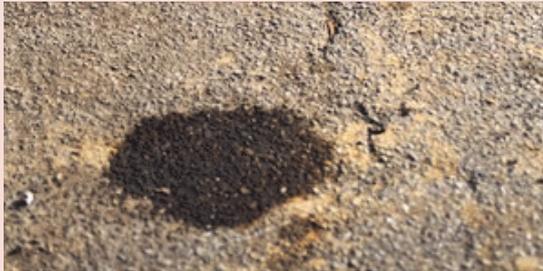
There are many places where oil leaks can occur on vehicles. Almost always, the causes are old or porous seals and o-rings.

This can also happen at the automatic transmission of the BMW 3 Series – especially where the transmission connector sleeve attaches. Should oil be leaking from here, besides the sleeve itself, the entire oil pan along with all seals must be replaced in order to ensure a reliable, leak-free seal again.

Upon an oil leak being detected at the transmission for all models with the transmission code 6HP19/6HP26, the transmission connector sleeve, the transmission oil pan and all seals should all be replaced together:

- Drain the oil – and if reusable, place it aside for refilling later
- Remove old oil pan and transmission connector sleeve, then install new sleeve and mount the new oil pan
- Refill transmission oil according to the instructions for maintenance

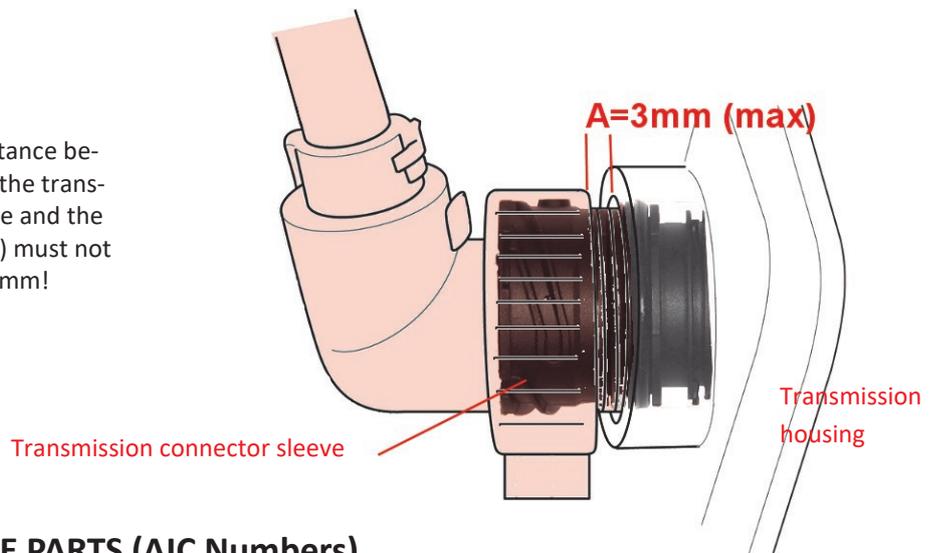
Important note: The distance between the screw cap of the transmission connector sleeve and the transmission housing (A) must not exceed a maximum of 3mm!
