BEST PRACTICE

Ford Mondeo, Ford Transit, Jaguar X-Type

THE SYMPTOMS

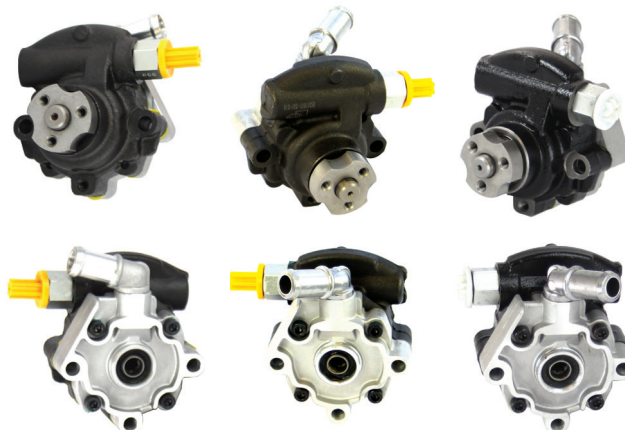
Power Steering Pumps:

PSP2310

PSP2315

PSP3300

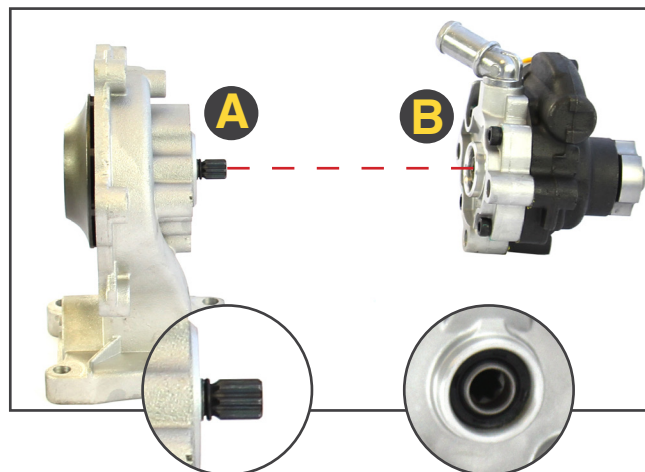
This family of Power steering pumps fit directly to the water pump. The power steering pump drives the water pump through a toothed (spindle) shaft. The Water pump shaft is the male part of this union (A), power steering pump is the female part of this union (B).

As the drive belt rotates the power steering pump pulley, the rotational movement is passed from this pulley to the shaft of the steering pump, and then in turn to the water pump shaft. Any misalignment can lead to the failure/snapping of the water pump drive shaft. This will cause a failure of either pump system.

The tolerance between the male and female section of the two pumps is critical, as the pumps wear, they will suffer from a loss of this tolerance. The replacement of only one of the pumps will potentially just be a short term fix. The critical tolerance required for optimum performance will not be present by fitting a worn Water Pump with a new Power Steering Pump, or visa verse.

BGA strongly recommend to always replace the water pump and power steering pump together for these applications, in order to retain optimum performance.
