### INCORRECT ASSEMBLY

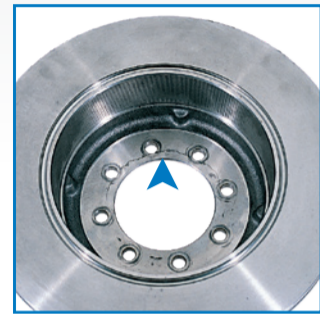
- APPEARANCE** Hub contact surface distortion, and/or cracking around the fitment holes
- CAUSE** Tightening sequence incorrect. Insufficient tightening torque used
- EFFECT** Vibration particularly on initial brake applications
- REMEDY** Replace the discs and adhere to both correct fitment sequence and manufacturer's recommended torque settings

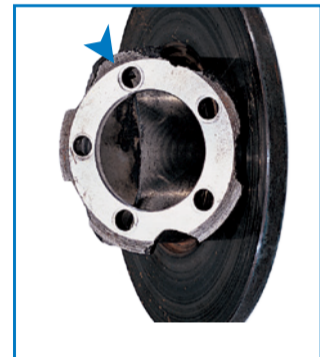
- APPEARANCE** Hub contact surface is detached or distorted
- CAUSE** Excessive tightening and failure to observe manufacturer's recommended torque and sequence during tightening
- EFFECT** Detachment of disc contact surface. Complete brake failure
- REMEDY** Full inspection of braking system and associated components. Replace any failed components and fit new discs observing manufacturer's recommended torque and sequence during tightening

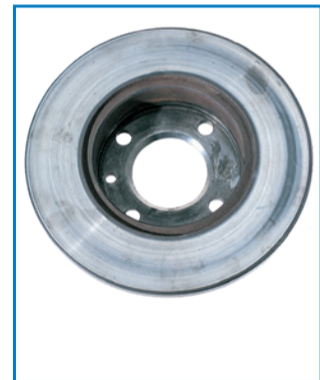
- APPEARANCE** Blue spots, darker colour of some disc areas. Evidence of localised overheating
- CAUSE** Excessive hub run-out. Uneven disc-to-pad contact generates excessive oscillation which in turn leads to localised heat generation – subsequently discolouration (blueing)
- EFFECT** Progressively increasing noise and vibration
- REMEDY** Correct the wheel hub run-out and ensure that this falls within the correct tolerances

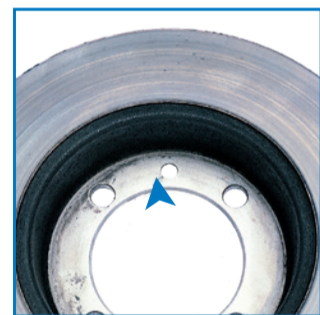
- APPEARANCE** Distortion of the hub contact surface and/or cracking around it
- CAUSE** Overly severe tightening torque used on the positioning screw
- EFFECT** Vibrations experienced from initial brake applications onwards
- REMEDY** Replace the discs avoiding excessive tightening torque. Positioning screws are only intended to ensure that discs are positioned correctly

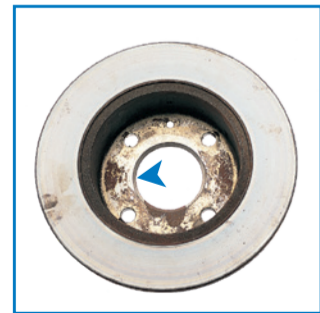
- APPEARANCE** Dirt and/or rust on hub surface
- CAUSE** Contamination on the hub surface can lead to misalignment during mounting leading to irregular contact between pad and disc surfaces and uneven wear of the disc
- EFFECT** Disc Thickness Variation which leads to oscillation of the disc surface resulting in noise and vibration. The effect becomes progressively greater with use
- REMEDY** Remove the disc and carefully clean the surfaces of wheel hub and disc, eliminating rust and other debris. Check that the support surface is neither distorted nor damaged. Replace discs observing manufacturer's recommended torque and sequence during tightening

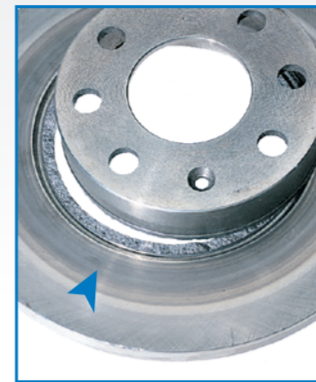
- APPEARANCE** Detachment of the disc hat from the braking surface
- CAUSE** Mechanical stress through misalignment. Incorrect assembly or positioning of the caliper and disc results in ongoing asymmetrical wear of the braking surface, eventually causing detachment
- EFFECT** Initially loud noise and vibration during braking with complete mechanical failure after detachment
- REMEDY** Full inspection of braking system and associated components. Replace any failed components and fit new discs observing manufacturer's recommended torque and sequence during tightening. Before fitting discs check the alignment and assembly of the caliper body on the axle

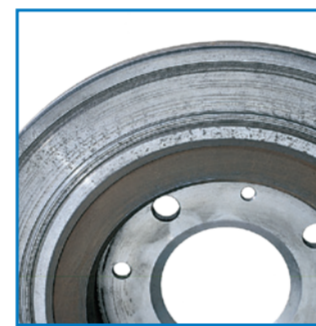
- APPEARANCE** Grooving on the disc
- CAUSE** The deep grooves are caused by loose abrasive particles between the pads and disc. Foreign debris may enter from outside the brake system (road, dirt, water) or from poorly mixed friction material
- EFFECT** Noise during braking and normal running, and lower brake efficiency due to reduced braking contact surface
- REMEDY** Replace pads and discs

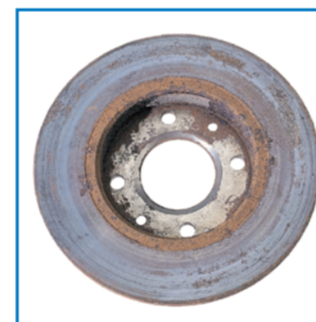
- APPEARANCE** Disc surface contamination – glazing and/or dark spots
- CAUSE** Friction material deposits have transferred to the disc surface. This usually occurs where poor quality brake pads have been fitted
- EFFECT** Vibration, poor braking efficiency and hard pedal
- REMEDY** Only install good quality brake pads with friction material suited to the brake and vehicle

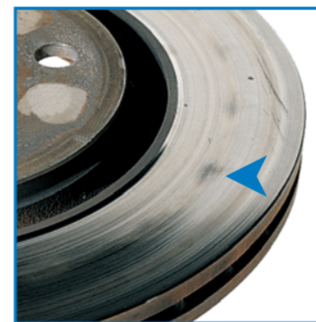
- APPEARANCE** Uneven wear of braking surfaces. Blue spots in the center of braking surface. Possible appearance of cracks
- CAUSE** Incorrect assembly of the caliper and/or pads can result in the pads being at differing angles to the disc, each side wearing at altered rates. The blue spots are generated by severe localised overheating where the friction contact occurs
- EFFECT** Gradual onset of vibrations, due to heat spots. Probable reduction of brake efficiency
- REMEDY** Check and, if necessary, repair the caliper. Replace pads, checking type and shape are correct for application

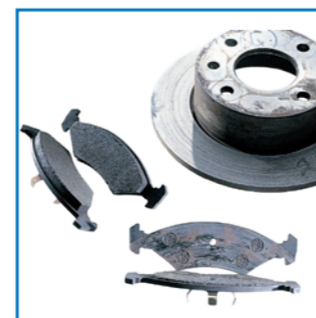
- APPEARANCE** Uneven wear of brake pads. Major wear on one pad with minimal wear on the opposing side
- CAUSE** Caliper seizure. One brake pad is in constant contact with the disc causing the pad to wear down to the metal backing plate. The side of the disc in contact with the backing plate becomes badly scored, while the other side of the disc and the other pad are practically new
- EFFECT** Ongoing grinding noise, vibration and low braking efficiency. Possible unbalanced braking action with vehicle pulling to one side
- REMEDY** Caliper needs to be checked, replaced or repaired. Replace brake pads and discs as necessary

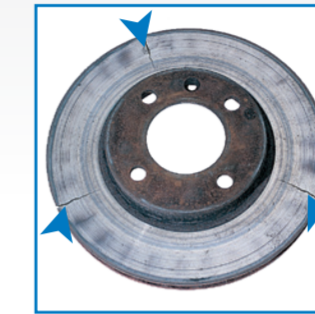
- APPEARANCE** Radial fractures/blue spots corresponding to the venting frames
- CAUSE** The blue spots are symptomatic of rising cracks. These are caused by metallurgical change in the surface material making it hard and brittle. This is typical of overloading the brakes beyond normal design limits. This could result from intensive or unusual brake use e.g. aggressive driving or excessive payload
- EFFECT** Brake fade/reduced brake performance, noise, vibrations
- REMEDY** Replace the discs, avoid abuse of the brake system and make more efficient use of the engine/gears to aid speed reduction

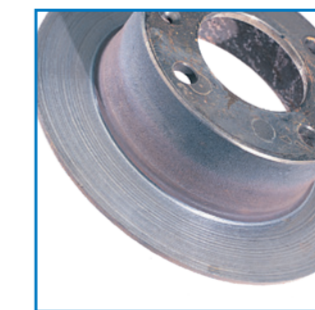
- APPEARANCE** Disc heavily worn with surface grooves
- CAUSE** Excessive or complete brake pad wear results the brake pad backing plate contacting the disc (metal to metal) damaging the disc surface
- EFFECT** Very low braking efficiency/increased stopping distances and grinding noise
- REMEDY** Replace discs and pads. Where applicable, confirm the pad wear warning indicator circuit is working correctly

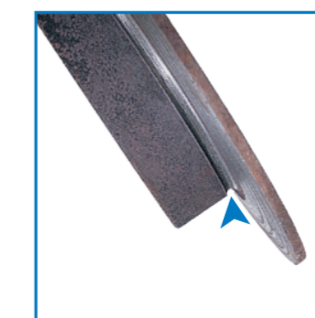
- APPEARANCE** Deep grooving between hat and disc surface
- CAUSE** Excessive pad and disc wear may lead to movement of the backing plate within the caliper. In this case, the backplate of the worn pad has come loose from its seat within the caliper causing grooving between hat and disc surface
- EFFECT** Very low braking efficiency with a long pedal stroke and heavy noise
- REMEDY** Replace discs and pads. Check and, if necessary, repair the caliper
