Blue Print ADP153316

Various Peugeot and Citroen models

Clutch Release Fork

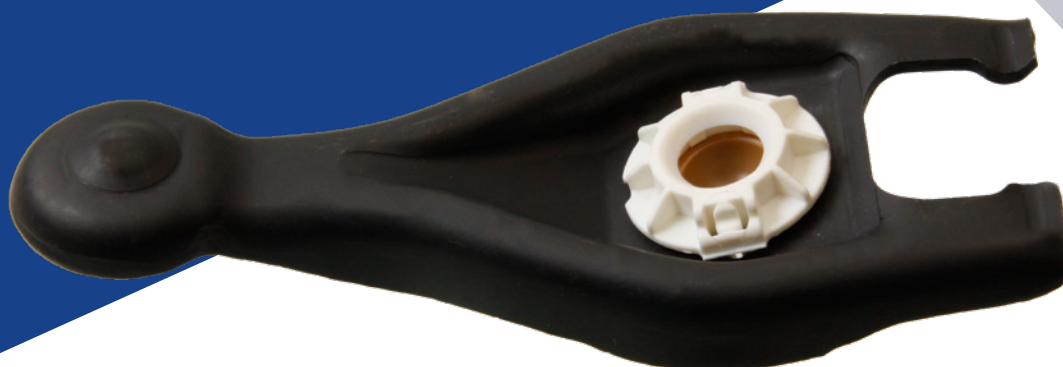
Difficulty in selecting gears when the clutch pedal is depressed, and a grating noise can also be heard when the clutch pedal is operated, this can be felt through the clutch pedal.

As the clutch wears and dust and debris build up, resistance in the clutch release mechanism increases putting more strain on the release fork. This causes the plastic bearing cup, which the release fork pivots on, to wear or break.

On removal of the transmission, inspect the clutch release fork, guide tube and clutch assembly and replace any worn or broken parts as necessary.
