# TECHNICAL REPORT

Crankshaft seal assembly with  
71011200 reference

reference 71011200

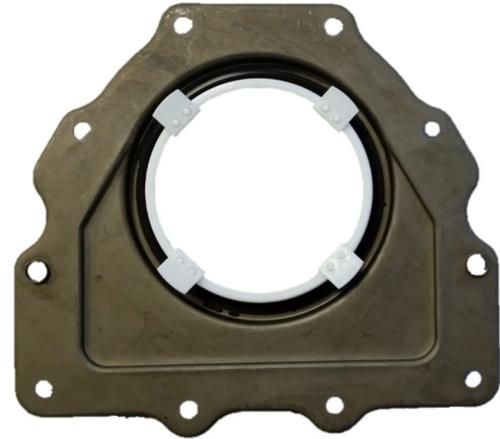
It is a seal with a cover, whose mounting location is the rear of the crankshaft of the vehicle.

This seal is mounted on Fiat, Mercedes - Benz, Nissan, Opel, Renault and Vauxhall models, with engine codes R9M. Correct installation of the seal is important to avoid oil leaks that could lead to future engine problems.

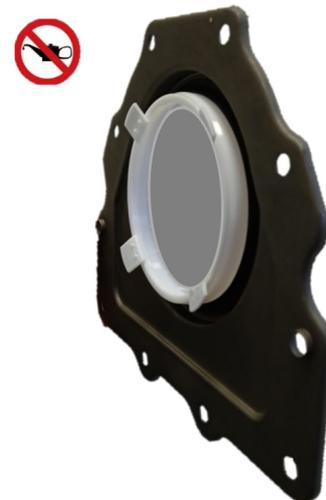
Place the crankshaft seal in its corresponding place, checking that it is centered and aligned correctly. Apply even pressure to ensure a good seal.

This is a PTFE (Polytetrafluoroethylene) seal so **neither the lip nor the shaft should be lubricated.** You should not remove the applicator yet.

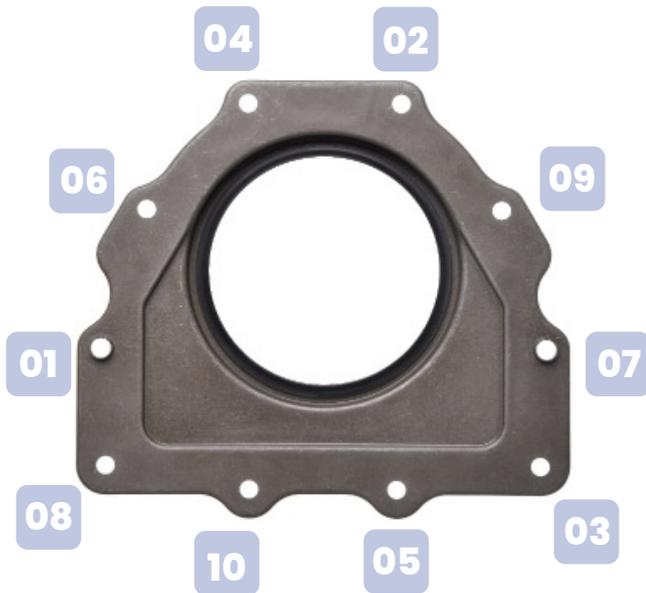
Tighten the cover fixing screws to a torque of 15 Nm in a crisscross pattern to ensure even tightening.

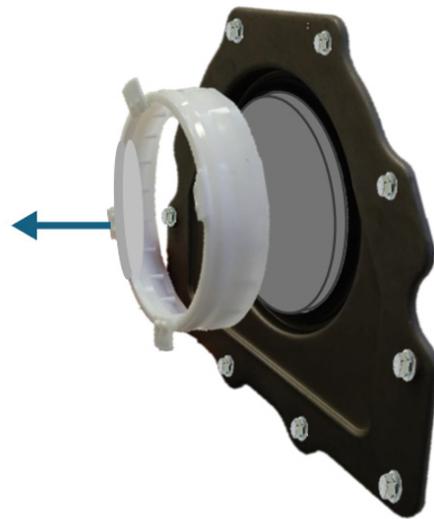
At this point, you can remove the applicator, being careful not to damage the sealing lip.

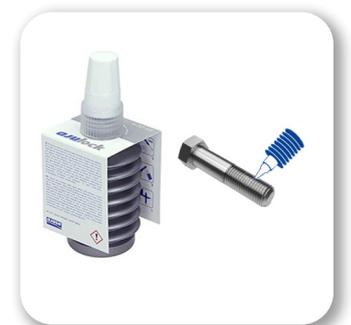
It is advisable to **apply Ajulock** locking agent to the flywheel bolts. This will help prevent unwanted loosening and leaks.
