SERVICEINFO

STUB AXLE

AIC article no.: 57202 / Oe reference no.: 4001 462 75R

Expandable: Not every stub axle breaks

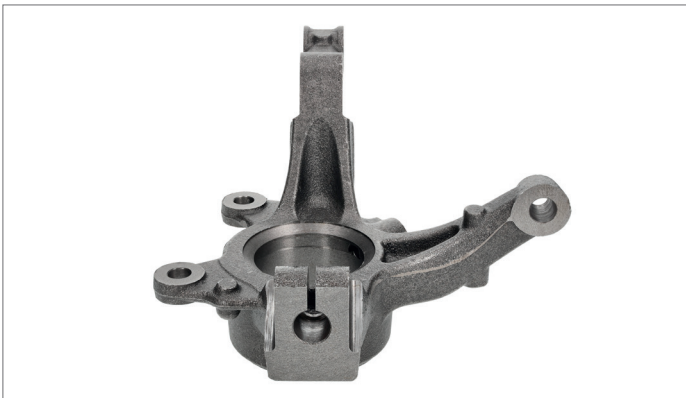
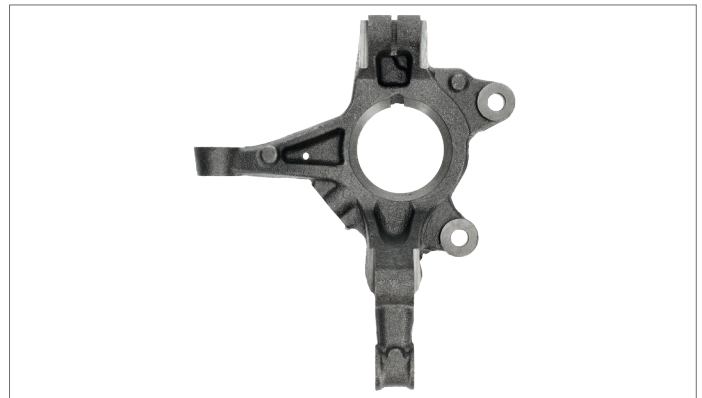
AIC art.no.: 57202 | OE ref. no.: 4001 462 75R

Accidents with effects on the axle geometry and thus a limited steering stability as well as changed grip of the tyres cannot be seen with the naked eye.

Among the vehicle parts that are particularly affected by this are steering knuckles, which can warp. Such damage is particularly possible in the event of accidents and sometimes even unfortunate encounters of the vehicle, for example with high kerbs or potholes.

- Limited steering stability
- Changed grip of the tyres

- Collision with another vehicle
- Driving over potholes
- Driving against kerbs

As a consequence, the axle geometry must be checked and, if necessary, axle parts replaced.

- Never heat the stub axle parts to loosen stuck screws.
This will change the metal structure of the stub axle!
- Always check the axle geometry when replacing the stub axle and correct it if necessary.
- Check with a test drive the correct alignment of the steering wheel, as well as the steering behaviour.
