УЕНМАК

Liner | Piston | Ring | Engine Bearing

Service Manual

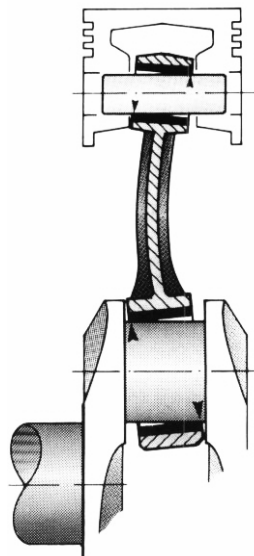
Figure 1

- Whereas there are marks of seizure on one side of the piston contact surfaces, there are marks of normal operation on the counter pressure direction. (Figure 1)
- There is no mark of seizure in piston ring areas. Marks of operation at the piston crown are normal.
- There are marks of burnt on the piston rings, although they are not evident.

The oil film on one side of the piston is lost and seizure occurs. This seizure especially occurs on the pressure dimension of the piston first. The reason is that the force applied on the pressure direction is higher than the counter pressure direction. The causes of corruption in the oil film on the pressure direction of the piston and unlubricated dry operation are as follows;

- 1 - During the engine overhauling operation, the cooling system should be checked, the cooling channels of the block should be cleaned and the parts to cause leakage of the coolant water should be replaced.

- 2 - Oils recommended by the engine's manufacturer should be used inside the engine.
- 3 - It should be checked whether the oil bores in the connecting rod should be open and operating.

- 4 - The oil level inside the engine should continuously be checked and oil should be added whenever required.
- 5 - The oil pressure should be checked. The causes of low oil pressure are worn oil pump, high amount of dirt inside the oil filter, faulty high pressure valve and corrupted viscosity of the oil. These parts should be checked and replaced.

- 6 - Engine oil should be replaced without any delay in accordance with the oil replacement intervals.
- 7 - Fuel and ignition system should be checked for fuel spillage, which might cause dilution in the engine oil.

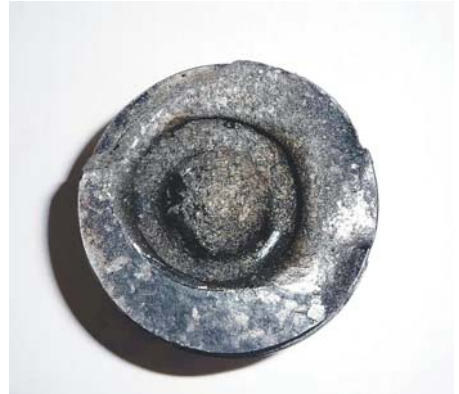
Figure 1

In direct-injection diesel engines, if the injection nozzle does not spray the fuel properly, unburned fuel remains inside the combustion chamber after the combustion time. Burning of the unburned fuel inside the combustion chamber continues during the exhaust time. The piston crown gets softer due to continuous burning and melts. The causes of this are;

- The injection nozzle needle is stuck in the groove.
- The injection nozzle needle does not cut off the fuel completely and continues to drip it.
- The injection adjustment is faulty or defective.
- The valve adjustments are defective and the valves cause leakage.
- The injection nozzle needle is blocked due to excessive carbon. It should be checked.

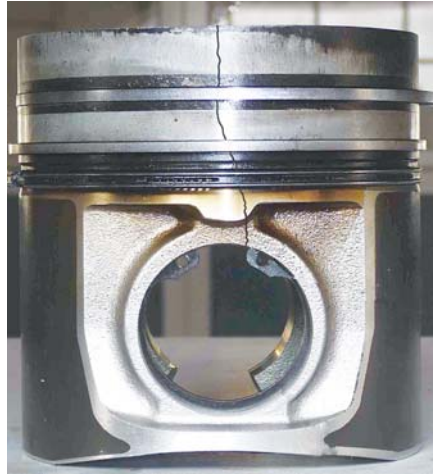
Figure 1

- The piston pin bore and the piston pin surfaces are not lubricated during the engine overhauling operation.
- In the engines, where the piston pin is tight in the connecting rod, assembly of the piston pin to the connecting rod is performed by heating the connecting rod. During this heating process, the temperature of the piston pin assembled into the connecting rod shall increase together with the temperature of the connecting rod. Upon expansion of the heating piston pin, the space between the piston pin bore and the piston pin shall be eliminated. The piston pin shall adhere to the piston pin bore surfaces. If the connecting rod is moved before waiting for the parts to cool down, there shall be scratches and abrasions on the piston pin bore surfaces. These abrasions shall progress with the initial operation of the engine and there shall be seizure in the pin bore. Therefore, the space between the piston pin and the piston pin bore should be checked after the parts cool down.

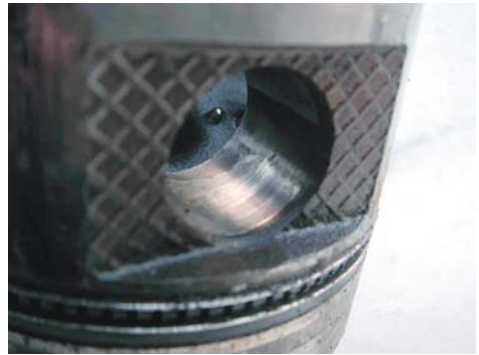
Figure 1

The piston pin in the connecting rod bearing to shrink fit and the piston pin in the pin hole to free

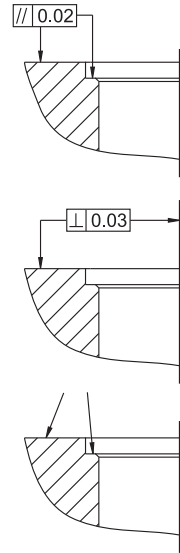
Figure 2

In order to avoid the oscillation movement of the cylinder liner inside the housing;

1. During rectification of the engine, while processing the cylinder block, adequate number of steel shims should be placed under the cylinder liner flange.
2. Or liners with flanges longer than standard values should be assembled.
3. The height difference between the block and the top point of the flange should be checked after the liner assembly.

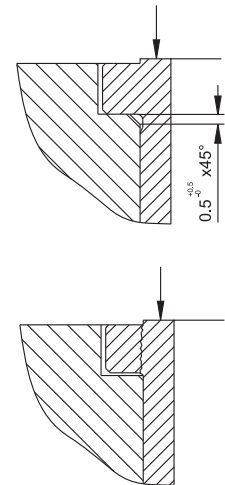
Figure 3

If the flange seating surfaces are inaccurate, the given measurements should be taken into consideration during correction and there should be a chamfer of 0.5 to 1 mm width under 45° angle at the corners. (Figure 3)

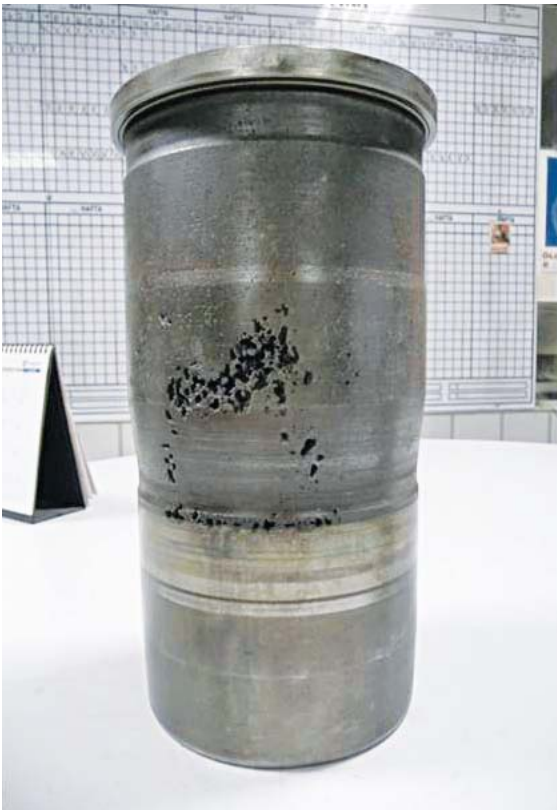
If the cylinder liner does not properly fit the cylinder block or if it is loose for the cylinder piston dimensions, the explosion at the ignition causes vibrations in the cylinder liner. These vibrations affect the flow of the coolant fluid. In this way, the cooling film on the outer surface of the liner is eliminated at certain areas. Steam bubbles occur on the surfaces, where the cooling film is eliminated, due to low pressure and high temperature. The steam bubbles start to hit the surface, where the film is not present in the liner. Due to the force applied by these bubbles, pieces snap off from the surface, holes and even pittings occur.

It occurs when used pistons are used again. Used piston is not appropriate for new cylinder liner, it is worn away and a space remains between the cylinder liner and the piston.

Anti-corrosion materials added into the coolant fluid are not adequate.

Fluids containing inappropriate coolant fluids (acid water, lime water, sea water or fluids containing hazardous materials) are used.

Since the thermostat is faulty, the engine cannot reach the required operating temperature and the cylinder and the piston cannot reach the required temperatures. Therefore, the required expansion cannot be achieved and a space occurs between the piston and the cylinder liner. This space causes steam bubbles and pittings.

In order to keep the pressure of the cooling system at the required level in the engine block, pressurized radiator caps are used. If the recommended radiator cap is not used, water leaks outside the system and as there is no adequate pressure, the boiling point of the water is reduced. The coolant fluid boils and steam bubbles occur due to the temperature of the cylinders.

During the engine overhauling operation, the cylinder liner, the piston and the piston rings should be used as a kit and they should be replaced within the same operation. Used products should not be assembled to the engine again.

Protective materials and anti-freeze should be added into the coolant fluid at the recommended level. Protective materials should be added continuously with small amounts as the vehicle is in use. Furthermore, the protective materials should be replaced in every two years.

Inappropriate coolant fluids (acid water, lime water, sea water or fluids containing hazardous materials) should not be used.

The radiator caps recommended by the engine's manufacturer should be used and inappropriate caps should not be assembled to the radiator upon third parties' recommendations.

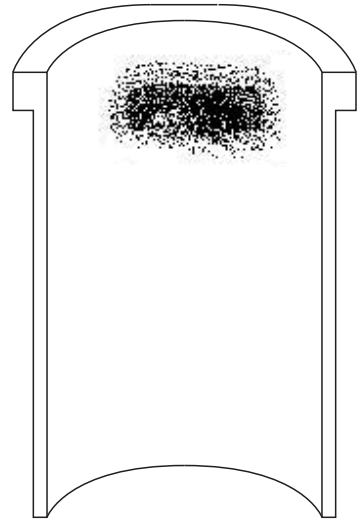
Figure 1

A mirror-like glaze and wearing occurs on the inner surface of the cylinder liner (Figure 1). Longitudinal polishing occurs at the areas where the piston rings operate. In this way, the sealing feature of the piston rings is eliminated and it cannot fulfill its function of sealing against oil and burnt gases. The oil consumption increases in the engine.

Tightness is important for dry-type cylinder liners. The cylinder liner is either too tight or too loose on the cylinder block.

If the engine block is not processed as recommended, it adopts the shape of the cylinder liner block with small wall thickness. This shape deformation attributes to the piston and the piston rings and the inner surface of the cylinder liner is worn away and polishing occurs.

Recommended cylinder head gaskets should be used.

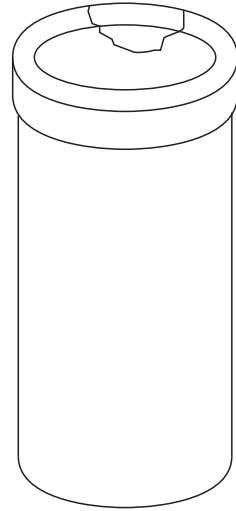
Figure 1

2.6. Crack Formation in the Cylinder Liners due to Hydraulic Lockout

The engine's fuel injection system should be checked and faulty injection nozzles should be replaced.

The engine of the vehicle should be overhauled.
