Engine DW 10 F  
Engine DW 12 R

VKMC 03317  
VKMA 03317, VKPC 83646

## Case study DW 10 F and DW 12 R engines

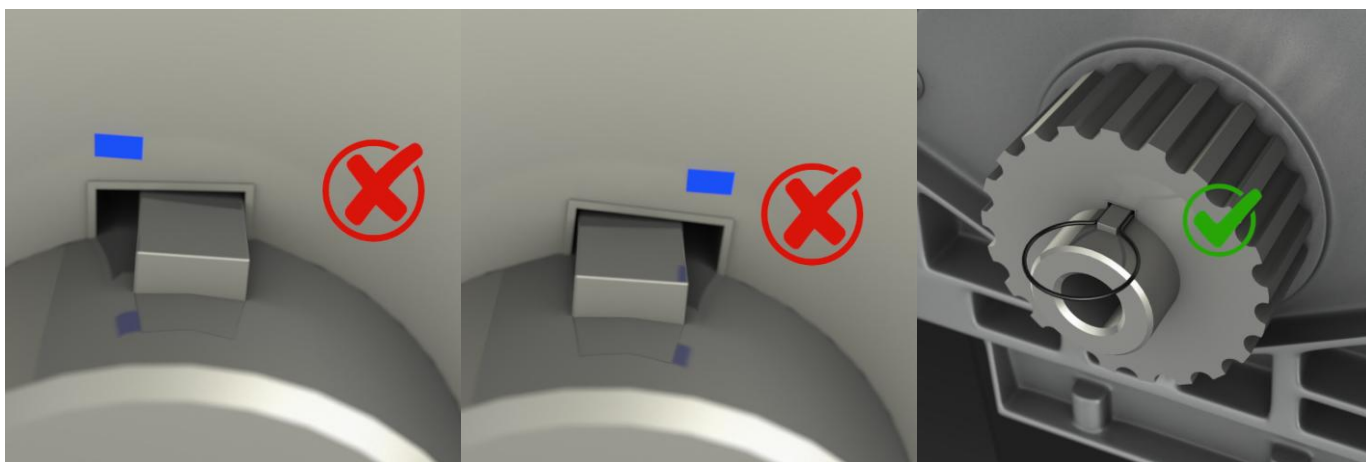
The crankshaft sprocket can be turned on the crankshaft within a certain range. It is particularly important to observe the specifications in the installation instructions. Some vehicle manufacturers use a clamp to centre the gear (see image). However, even without the use of the clamp, it is always important to ensure that the crankshaft sprocket does not rest against the stop of the twisting range when fitting the timing belt.
