TECHNICAL REPORT

Ajusa New Product
EGR valve pipe

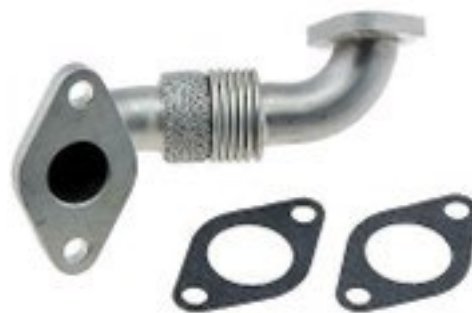
- 1. Remove components:** Remove components that may hinder access to the EGR pipe, such as the engine cover or the intake manifold.
- 2. Disassemble the EGR pipe:** Loosen and remove the screws or clamps that hold the EGR pipe, being careful not to damage other parts of the system.
- 3. Cleaning:** Clean any carbon residue on the connection areas using a suitable cleaner.
- 4. Install the New Tube:** Install the new EGR pipe and make sure it is tight. It is recommended to replace the connection gaskets.

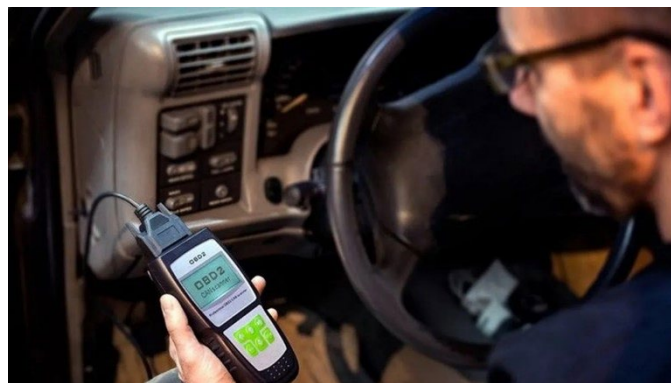
Once the EGR pipe has been replaced, we can carry out a check by starting the engine and checking that there are no leaks. We can also perform a diagnostic scan for error codes.
