Valve Face Wear

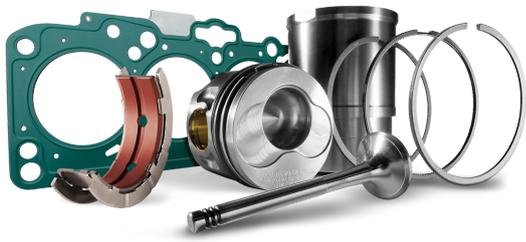
Exhaust Valve Face Wear

This does not usually effect modern engines. Engine manufacturers spot its occurrence during development, and correct it, typically by the use of a stellite seat. However, on earlier engines without hard faced seats valve face pounding and wear can occur. This is due to high engine temperatures, coupled with slack tappets or weak valve springs.

Before the use of non-leaded fuels and LPG, the products of combustion adequately lubricates the exhaust valve. However, the exhaust gases in these fuels are relatively dryer and lubrication free. This increases valve face wear; revision of valve geometry, valve and seat materials and cast iron head metallurgy prevents it

Possible causes of exhaust valve face wear:

- High engine temperature coupled with excessive tappet clearance, weak valve springs etc.
- Valve to port seat misalignment.
- Engine operated on either low lead or LPG fuel (Petrol engines)
