# febi 183819

To fit: Mercedes-Benz A-Class (169),  
B-Class (245)

## Driveshaft

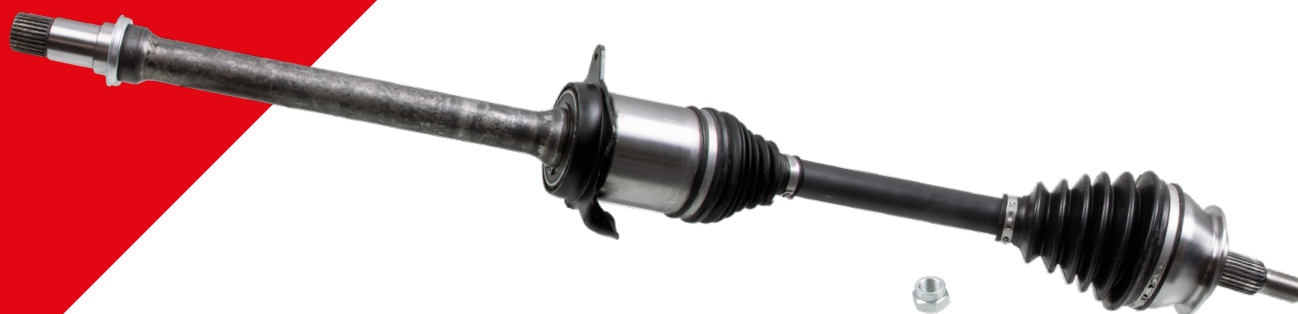
Loss of drive. The car remains immobilised with gear selected and engine revs increase when the accelerator is pressed.

Warning lamp illuminated, with the following fault codes stored in the automatic transmission control unit:

0723 Output shaft speed sensor: Rotational speed Signal improbable

2732 CVT transmission: Forward gear solenoid valve impermissible opening

This fault initially suggests an internal mechatronics issue, potentially involving damage to one of the solenoid valves, or a faulty oil pump, heavily contaminated gearbox oil and a blocked filter, or even a failure within the unit itself.

However, this fault may be due to a mechanical issue: a broken right driveshaft. The splines within the outer constant velocity joint have worn, resulting in it being unable to transfer motion to the wheels - the driveshaft rotates but the bearing does not.

Raise the vehicle and check if the driveshaft rotates by hand and drives the wheel. If not, remove the protective rubber boot from the outer CV joint and confirm the diagnosis. Replace the worn driveshaft, check the service history of the transmission and replace the oil and filter if required. Reset any fault codes using a suitable diagnostic tool and road test.
