febi 22044, 39076

To Fit:
Various Volkswagen group vehicles

Tie Rod End

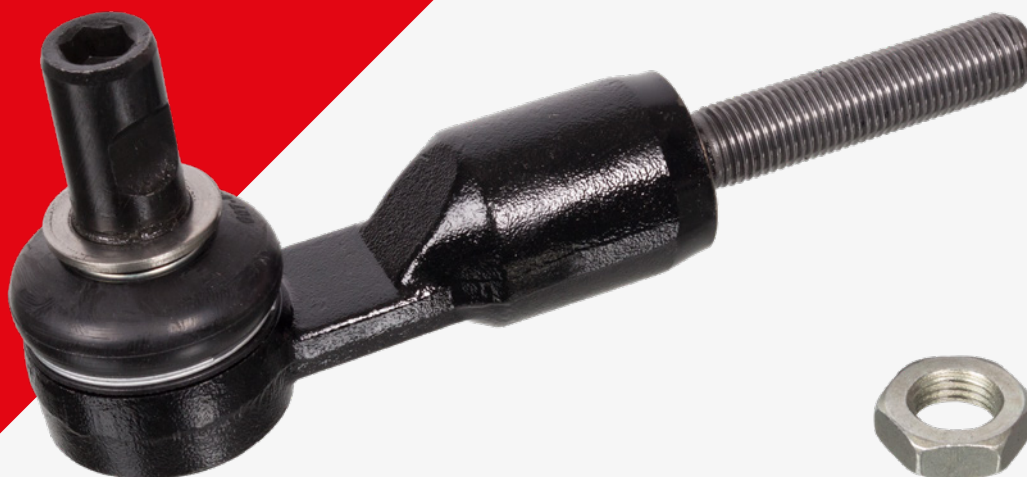
Knocking or creaking noises may be heard from the front suspension area while driving.

The original design of this tie rod end is highly susceptible to wear. This is due to insufficient material dimensions; the wear is accelerated when the vehicle is driven in harsh road and weather conditions.

febi recommends the use of the tie rod end 22044, which has the following improved features:

- Larger diameter to increase the load carrying capacity
- Stronger body
- Snap ring is replaced by a flange to protect the rubber boot

With this new design, the rubber remains in the housing to ensure a comfortable driving experience and to prevent high-frequency vibrations being transferred to other parts.
