Service Info

Tensioning arm 534 0325 10

Improved markings

Manufacturers:	Dodge, Mitsubishi
Model:	
Dodge:	Caliber
Mitsubishi:	ASX
	Lancer
Engines:	
Dodge:	1.8, 2.0, 2.4, 2.4 Turbo
Mitsubishi:	1.8
Part no.:	534 0325 10
OE number:	
Dodge:	04891976AC (replaced)
	04891595AD (new)
Mitsubishi:	1345A059 (replaced)
	1345A079 (new)

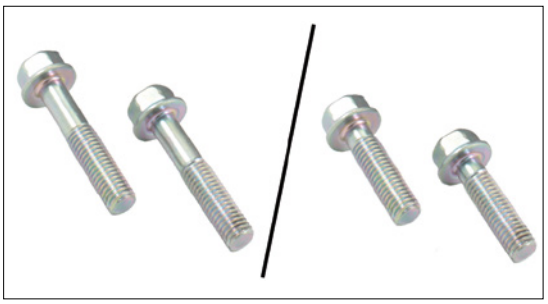
As a result of the modified attachment point dimensions, the length of the fixing screws has also changed. The M8x40 mm screws from the old version can no longer be used with the modified tensioning arm. They must be replaced with the M8x30 mm screws provided (image 4).

Image 4: Left, old M8x40 mm screws.
Right, new M8x30 mm screws.

It is essential that the screws provided are used when installing the modified tensioning arm.
