To fit:
Mazda 3 (BK), MX-5 (NC)

Wheel Bearing Kits

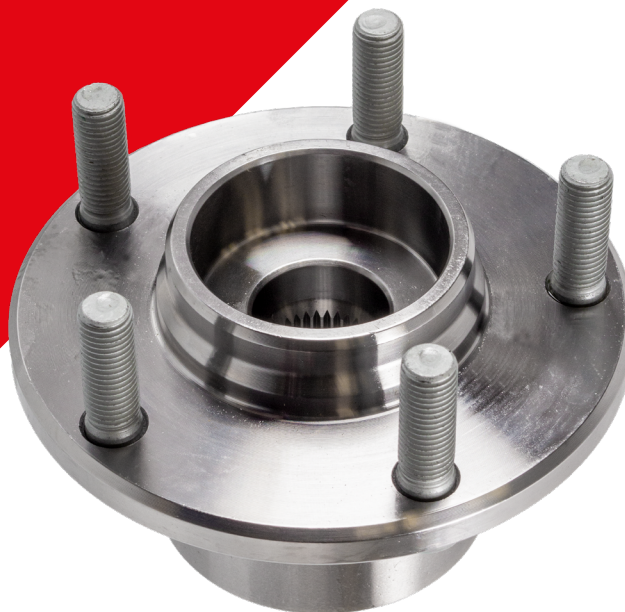
Thoroughly clean the mating surface between the wheel bearing/drive flange and the outer CV joint using a suitable degreaser. When the mating surface has been degreased apply a light coating of molybdenum grease (febi 025821) between the two surfaces and reassemble using a new hub nut.
