TRUNK LATCH ACTUATOR RELAY LEVER UPGRADE KIT

for AUDI and VW

OE: 1J5 827 567A

Triscan SELECT: 8900 29588

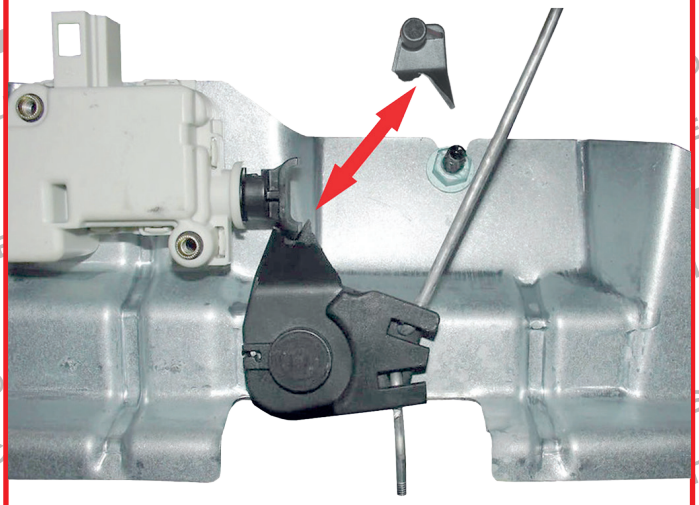
OEM Design

The trunk release actuator found in the VW Jetta MK4 is known for breaking the thin plastic relay lever, which disables the latch release mechanism. Repair typically requires replacement of the entire actuator bracket assembly, which is no more durable than the original failure-prone assembly.

- Actuator usage breaks the plastic relay lever, especially during cold weather.
- Replacement of OE bracket assembly is a costly yet temporary repair, and doesn't resolve the fragile relay lever issue.
