# febi 199055

To fit: Jaguar XE (X760),  
Land Rover Discovery Sport (L550),  
Range Rover Evoque (L551),  
Range Rover Sport (L494)

## Gear Shift Gate / Parking Brake Actuation Repair Kit

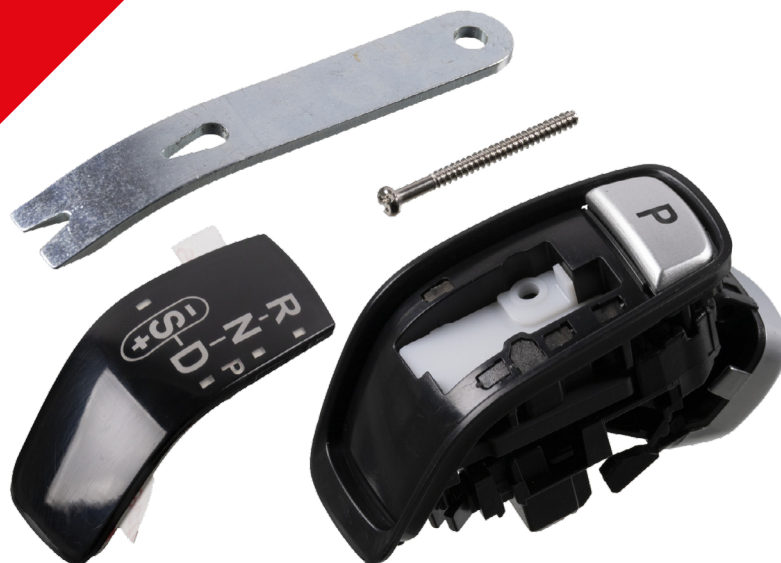
Unable to select gear, vehicle stuck in park.

The gear shift release trigger button mechanism breaks internally. Therefore, the transmission control switch is unable to communicate with the transmission control module and other system modules to select a gear.

febi Gear Shift Gate / Parking Brake Actuation Repair Kit 199055 contains all the components included to resolve this fault.

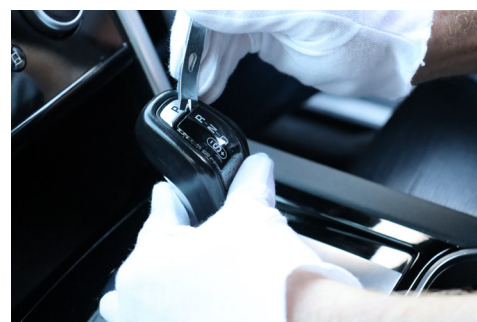
Fig. 1

Ensure the ignition is switched off. Then, use the tool provided to release the adhesive to remove the decal on the gear shift. (Fig. 1)

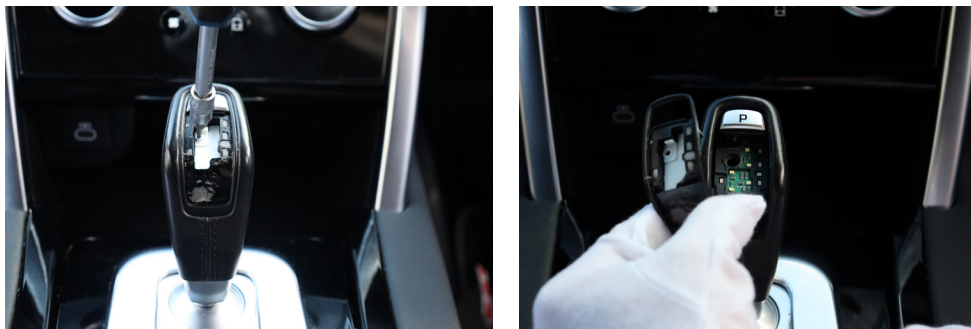
Fig. 2

Remove the screw and release the outer bezel. (Fig. 2)

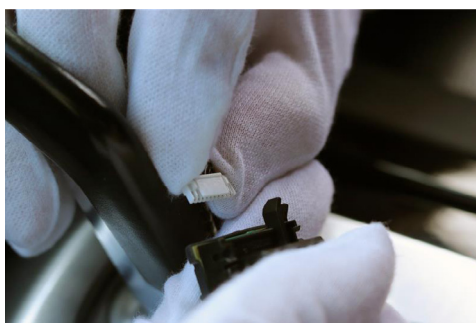
Fig. 3

Push the release trigger button through the gear shift lever, then unclip the wiring harness. (Fig. 3)

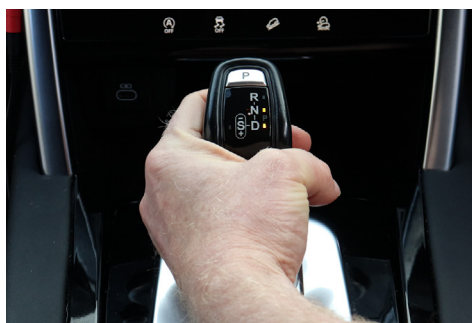
Fig. 4

Install the new switch assembly and bezel into the gear shift and tighten with the new screw. Test operation of the gear shift. Check the operation of the trigger and the gear shift module functionality, making sure all gear positions can be selected: Drive, Neutral, Reverse and Sport. Remove the adhesive backing strip and install the new decal, ensuring it is correctly aligned. (Fig. 4)
