THE SYMPTOMS

THE REASON

VALVE APPLICATION

THE SOLUTION

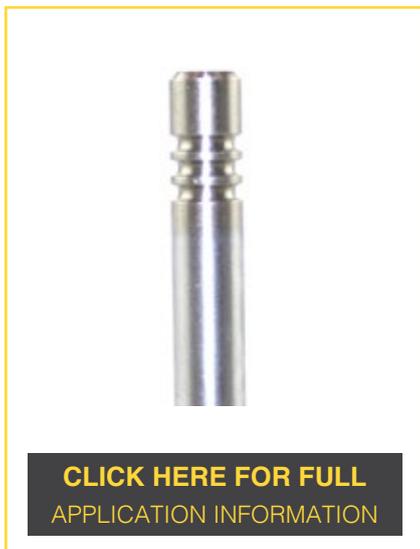
BGA PART NUMBER	VALVE TYPE	OE NUMBER	HEAD DIAMETER	STEM DIAMETER	LENGTH
V033394	Exhaust Valve	058 109 611E	29.8mm	6mm	103.9mm
V033413	Inlet Valve	058 109 601C	26.9mm	6mm	105.1mm
V033438	Exhaust Valve	058 109 611M	29.8mm	6mm	103.9mm

- Always double check the VIN code before ordering.
- Check that the correct Valve is to be installed.
