TECHNICAL REPORT

Selection of cylinder head gasket 101573X0

PURPOSE

Inform our customers about the distribution of notches in cylinder head gaskets ref: 101573X0 in HDI engines of 1997 cc and 2179 cc for vehicles Citroën, Fiat, Ford, Lancia, Peugeot, Suzuki, Tata and Volvo.

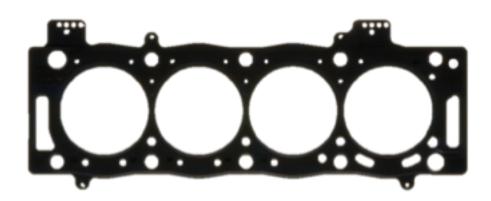
Next, an example of **reference 10175330** (5 notches). Its observed how the cylinder head covers on of the notch.

If the customer requested the gasket without previously disassembling the engine, he would only appreciate 4 of the 5 notches contained in the gasket. Therefore, in this case, the customer must ask about the gasket with 1 notch more than the ones observed.

GASKET + BLOCK

CYLINDER HEAD + GASKET + BLOCK

In the case of **reference 101573X0**, when the customer choices the thickness of the gasket, **an error can be caused** due to a notch that is hidden by the cylinder head and the block. Ajusa counts with this hidden notch. The only way to appreciate this notch is dismounting the cylinder head.
