Visual differences of the tensioning pulley 531 0565 30

LuK AS Part No.: 531 0565 30

This Service Information shows the visual characteristics of the „old version“ and the „new version“.

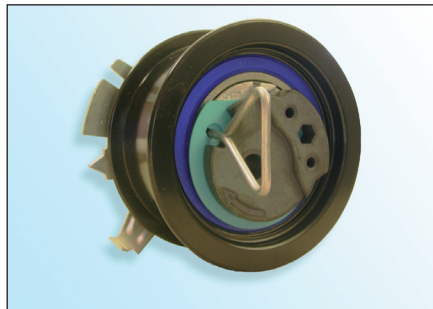
Fig. 1: 531 0565 30 (old version)

Visual characteristics:

- Cam made from sinter metal
- Surface coat E-Coat (black)
- Blue bearing seal

The „old version“ of the tensioning pulley is **not** made completely redundant and can still be used and assembled in accordance with the instructions provided by the manufacturer!

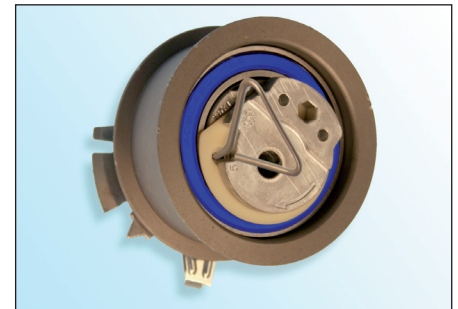
Fig. 2: 531 0565 30 (new version)

Visual characteristics:

- Cam made from cast aluminium
- Surface coat Zinc phosphorous (light brown)
- Brown or blue bearing seal

When assembling the „new version“, ensure that the surface coat of the tensioning pulley is **not** damaged!
