# Technical Instruction

## Fitting instructions: wheel bearing set

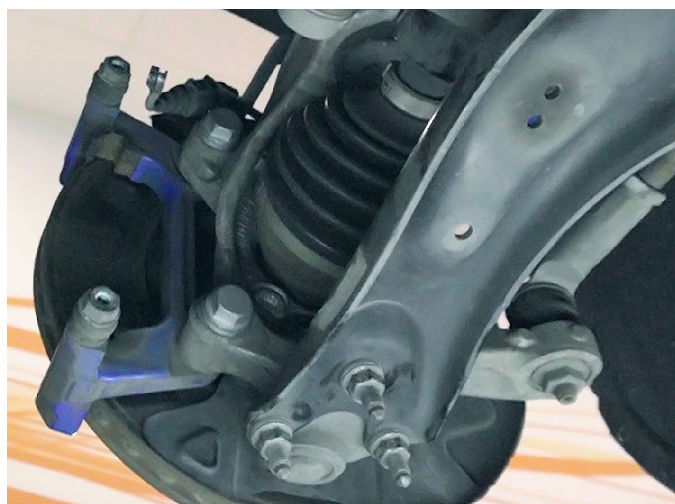
### Damage scenario 2: Defective axle components

**Possible causes:** fit is compromised, oval deformation of the axle parts

**Consequences:** bearing not fitting correctly, moisture ingress, noises

- › Check axle components for correct function
- › Check wheel mount
