Fitted with the 1.6 CDTi engines
LVK, LVL, LVM, LWQ, LWV

Gasket for Timing Chain Tensioner

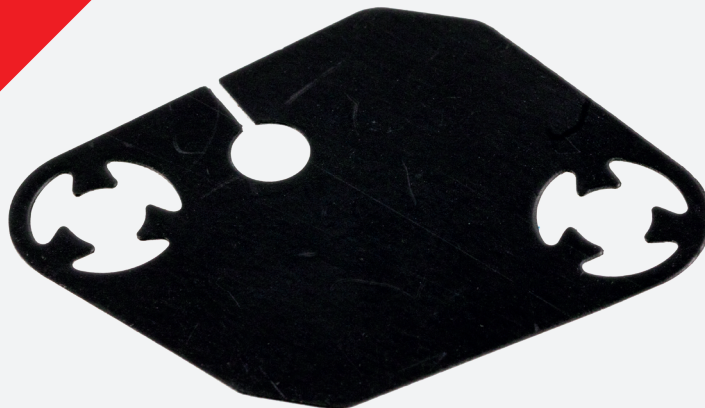
The engine emits a rattling noise from the timing chain area when starting from cold or after an extended period of time.

The original design of the timing chain tensioner allows the engine oil to drain back into the oil pan. This means that when the engine is first started it takes time for the oil to reach the operating pressure necessary for the timing chain tensioner to work correctly. This then allows the timing chain to move excessively, resulting in a rattle coming from the camshaft drive area.

Installing febi Gasket 181945 between the timing chain tensioner and the engine block creates a reservoir of oil, preventing it from draining back into the engine. This enables the tensioner to function and provide the tension required to absorb the shock and vibration of the chain as it rotates at start up.

Check that the camshafts, oil pump, and timing chain components are in correct working order, and replace any worn or faulty parts as required.
