SKF Technical Bulletin

VKBA 1441 – Fitting Instructions

ALFA 145, 155
 FIAT Tipo, Tempra, Tipo, Coupe
 LANCIA Dedra, Delta II

Fitting instructions: Caution when mounting the Wheel bearing kit VKBA 1441

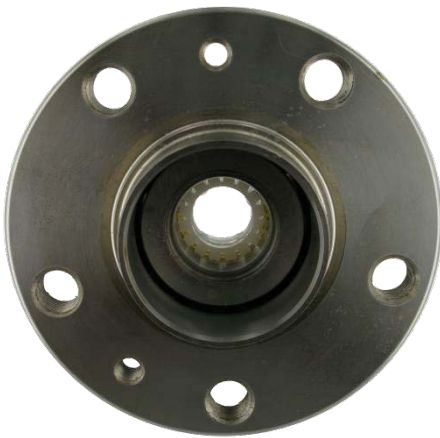
SKF use safe packaging solutions to protect the wheel bearing from damage during transport or mounting. VKBA 1441 is delivered with a plastic joining sleeve, to keep the inner rings together, until the bearing is mounted on the car.

Bearing with plastic
 Joining sleeve

- Never remove plastic sleeve before mounting the bearing, as this will separate the inner rings
- Always use correct mounting tools
- Apply the correct force on the bearing inner ring

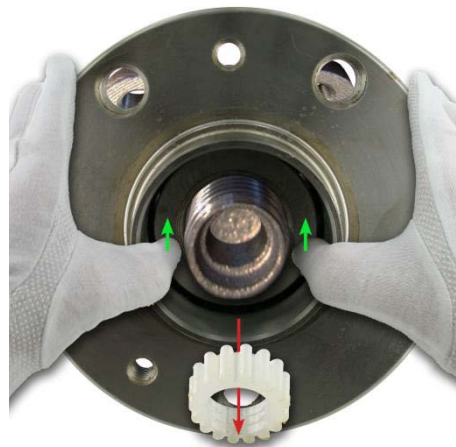
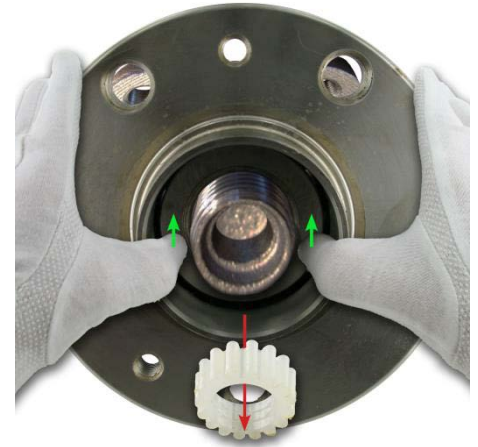
The plastic joining sleeve ring will be automatically pushed out by the axle stub, when mounting the bearing in a correct way, applying the force on the inner ring. Do not push out the plastic sleeve manually before mounting.
