# febi 1001193, 1001194

To fit: Various Volkswagen, Audi, SEAT  
and Škoda models

## Anti Roll Bar Bush

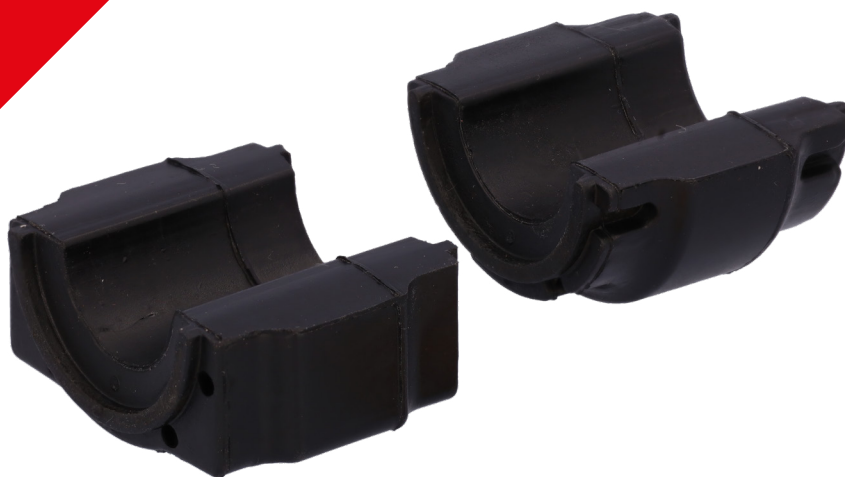
Squeaking and creaking noises from the front suspension when traveling on uneven surfaces.

With age and increased mileage, the anti-roll bar rubber bushes deteriorate and no longer provide the same level of support as when the vehicle was new.

On many Volkswagen Group vehicles built on the MQB platform, the manufacturer does not supply these anti-roll bar bushes separately. febi offers them as individual components, allowing for a more efficient repair without the need to replace the entire anti-roll bar.
